## **DSI ENGINEERING – COAL/GAS FIRED POWER**

## **RECOVERY & REPAIR PLAN OF DERAILED STACKER**[W10211-002]

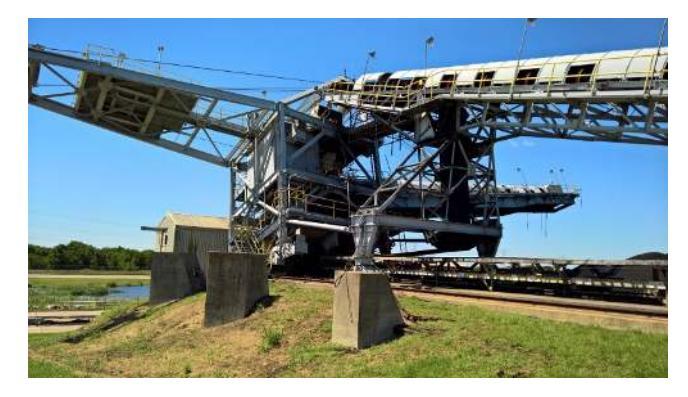
Figure 1: De-Railed Stacker

Sudden extreme high winds overtook the plant stockyard and subsequently swept away an unsecured coal stacker. The stacker was propelled southward down the track and traveled through the end stops, until finally coming to a rest. Tilted on the hill side with the yard conveyor truss to the drive house crushed beneath it, the stacker's forward travel gear was found buried into the earth and its back travel gear dangling from the gantry structure.

DSI was tasked with assisting in the plan to lift the stacker back onto its rails and designing temporary support stands to support the forward corners where the travel gear was destroyed. Inspection revealed much damage, chiefly caused by the accident but also a substantial amount was due to weather exposure and coal related corrosion. Crane specialists were contracted to develop a rigging plan and DSI issued an inspection report with recommended repairs and designed temporary corner support stands, in addition to special required repairs.
